Inspection Report

Sample Report

Property Address:
123 Sample Way
City of Inspection NH 123456

Scenic Home Inspections, LLC

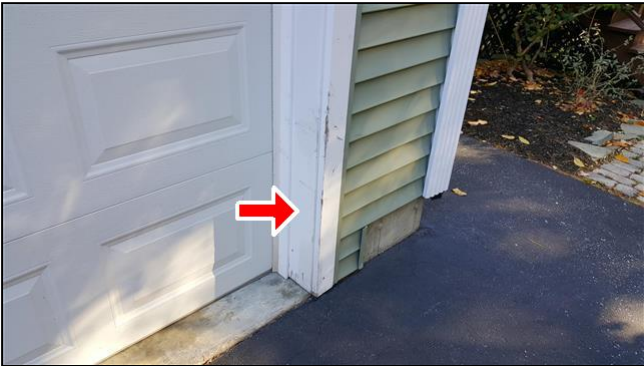
3.0 Item 1

3.0 Minor damage at garage door trim.

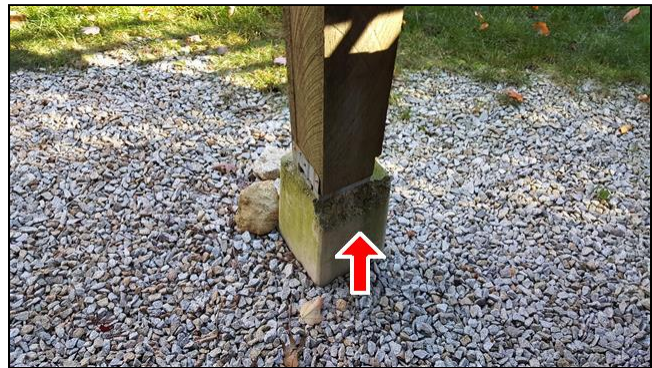
3.3 Several of the balusters are rotted. Recommend qualified professional evaluate railing system and repair as needed.

3.3 Item 1 CEMENT ERODING

- 3.3 Decks, Balconies, Stoops, Steps, Areaways, Porches, Patio, Cover and Applicable Railings (Exterior)**
Requires repair, maintenance, or replacement.
Several of the balusters are rotted. Recommend qualified professional evaluate railing system and repair as needed.
- 3.4 Vegetation, Grading, Drainage, Driveways, Patio Floor, Walkways and Retaining Walls (With respect to their effect on the condition of the building)**
Requires repair, maintenance, or replacement.
Minor settling and separation of pavers at front walkway. Some of the pavers on the steps are loose. Recommend repair as needed.

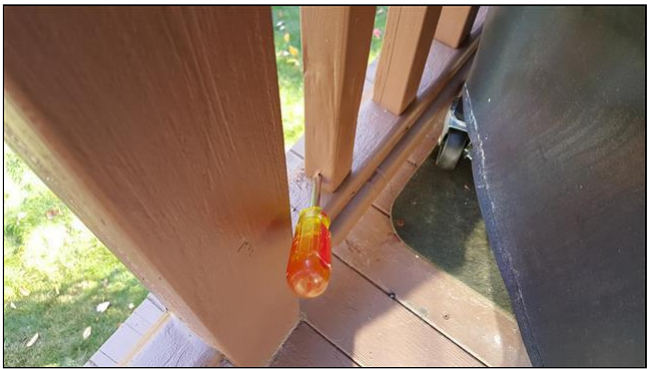
3.3 Item 6 MORE ROT

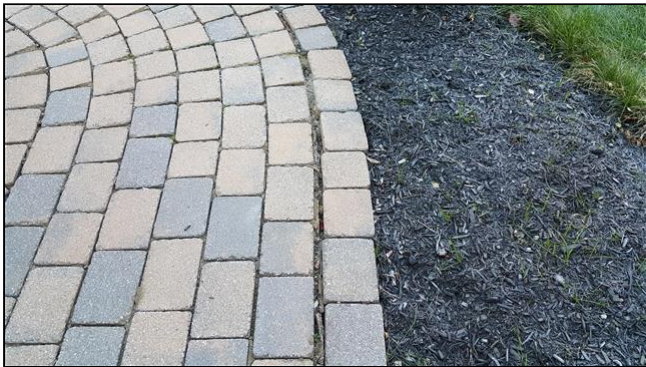
3.4 Item 1

3.4 Minor settling and separation of pavers at front walkway. Some of the pavers on the steps are loose. Recommend repair as needed.

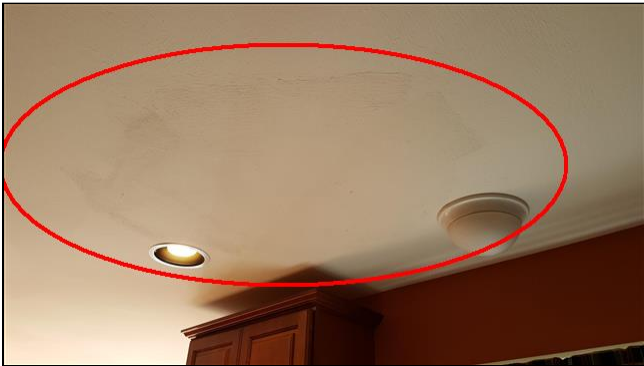
4.0 There is a patch in the kitchen ceiling, most likely from a water leak at the 2nd floor bath. No issue at this time.

4.0 Item 1 PATCH AT CELING IN KITCHEN-NO ISSUE

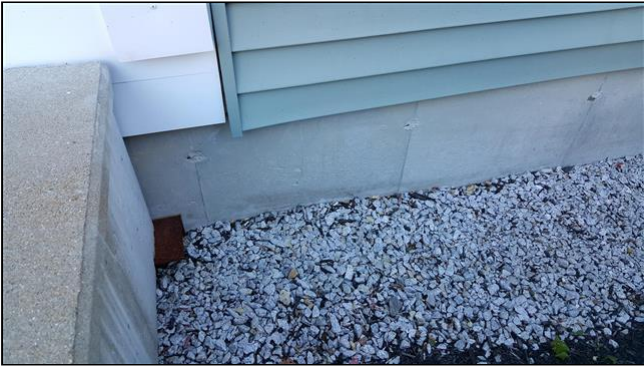
5.0 There are minor settlement or expansion cracks in the street side concrete walls. Monitor and evaluate for repair if these get worse. Consider sealing as needed. There are no signs of moisture penetration at this time.

5.0 Item 1 SMALL CRACK NOT VISIBLE

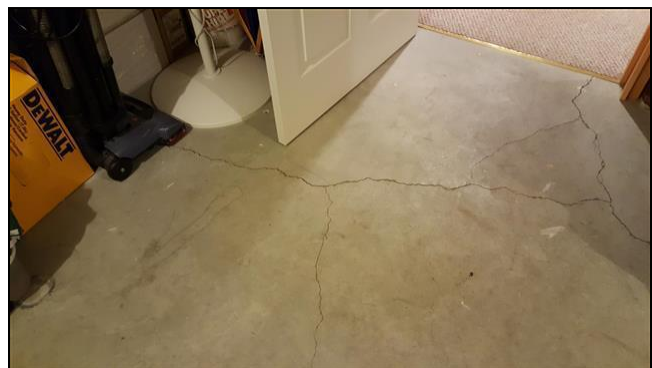
5.4 Item 1

5.4 Some heaving in the basement. There are several cracks, but not more than 1/4" wide. Monitor and seal as desired.

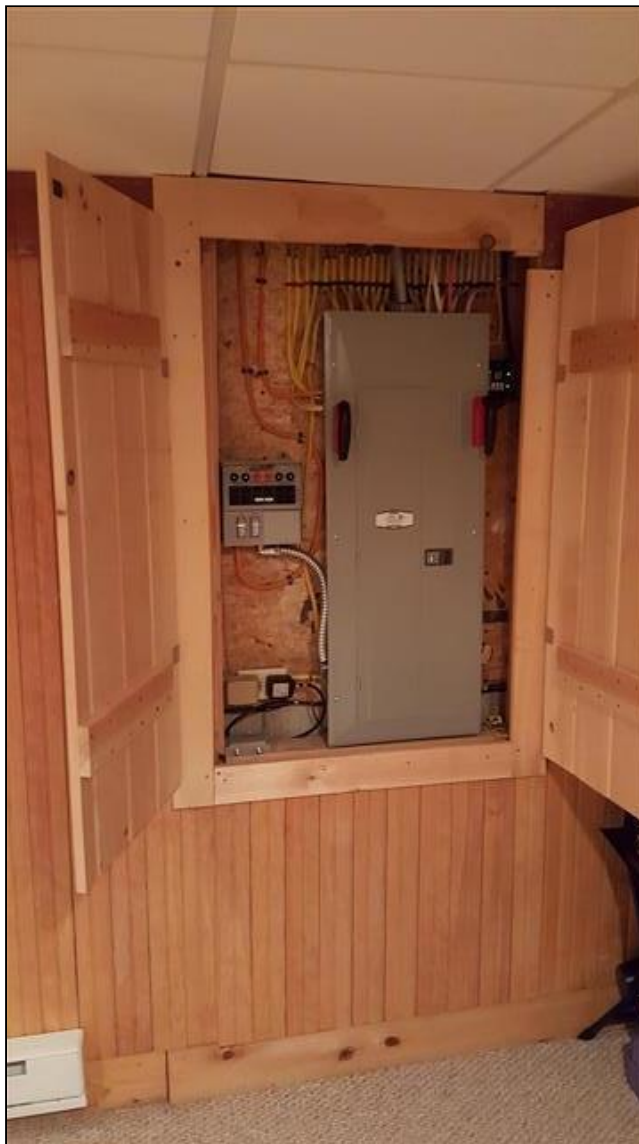
7.1 Item 1

7.1 Main distribution panel.

There was one wood screw out of six holding the panel. I left the wood screw on top of the transfer switch.

There is an emergency generator system. This was not inspected.

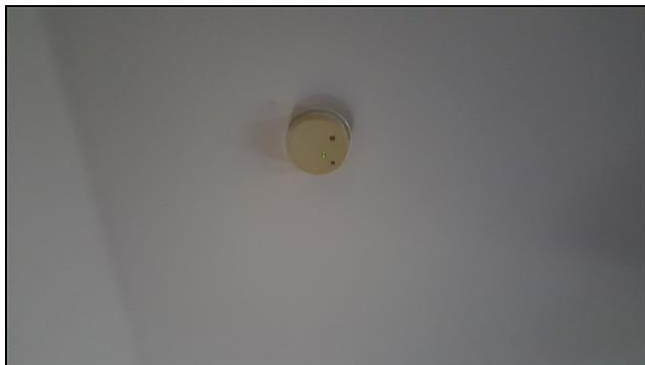
7.5 The smoke detectors appear to be over 10 years old and although they tested good, it is recommended to replace them due to age.

7.5 Item 1 MORE THAN 10YEARS OLD

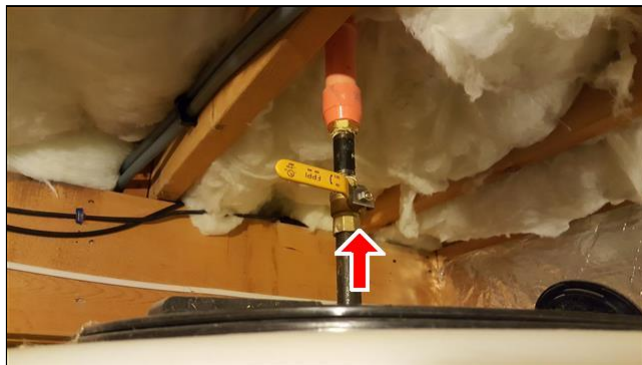
7.5 Item 2 HAVE VALVE CHECKED BY LICENSED PLUMBER FOR PROPER POSITION-SAYS ON BUT ON IS USUALLY IN A VERTICAL POSITION

Recommend buyer contact alarm company to go over proper operation and maintenance of safety systems.

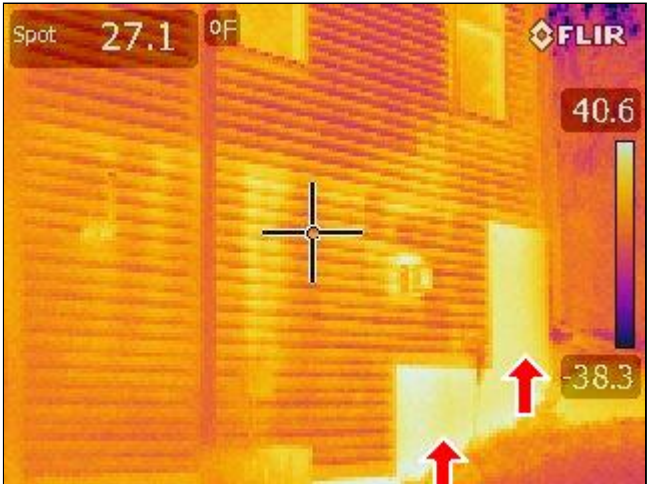
11.0 Item 10 HEAT LOSS AT BASEMENT

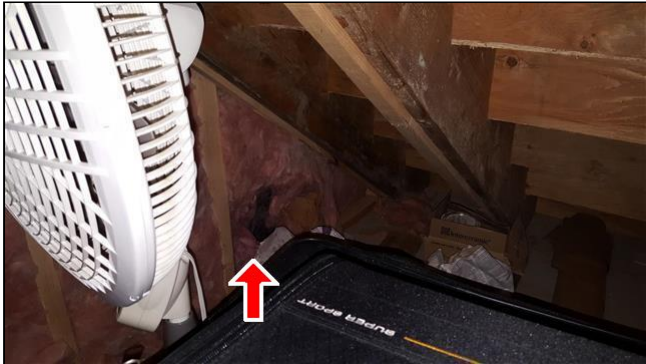
13.1 Item 1

13.1 Insulation pulled away indicating some sort of wildlife or pest present.

Recommend evaluation and treatment by certified pest control professional.
